SAFETY COMMITTEE MEETING

RE: RASP QUARTERLY SITE INSPECTIONS

On January 3, 2019, I conducted a safety inspection for the Antelope Valley College. The purpose of the visit was to conduct site safety inspections at all four campuses and identify potential workers' compensation hazards and/or property and liability hazards. The areas visited during this quarterly inspection are listed below:

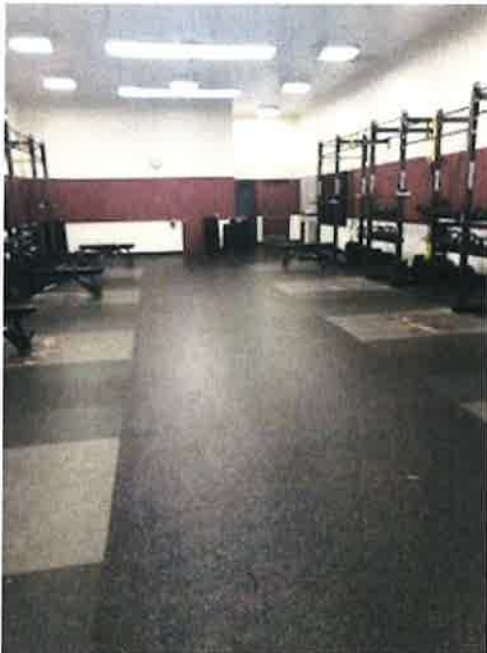
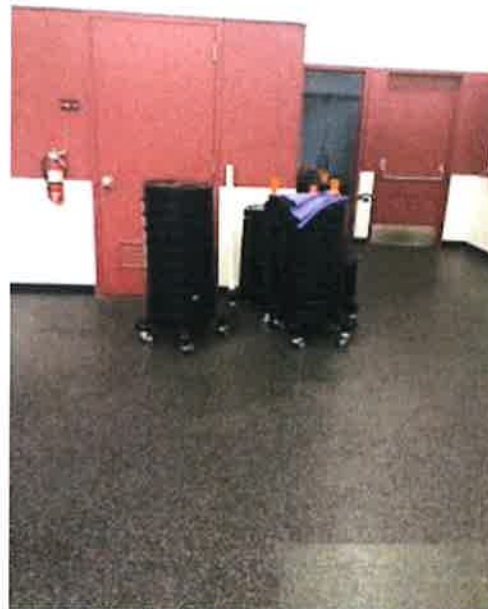
Photo 1 – New Weight Room Layout

The weight room is a complete improvement under the direction of Thomas Gang, Athletic Director. In prior inspections, the room revealed several safety concerns with loose or damaged floor mats, weights on the floor and poor lighting. The new weight room has new weight equipment, and the entire gym floor is cushioned and designed for an athletic environment. Weights are stacked on a rolling rack for easy access and clean up. Mr. Gang also worked closely with campus security to improve student accountability. The site should consider posting gym rules as a reminder for all occupants.

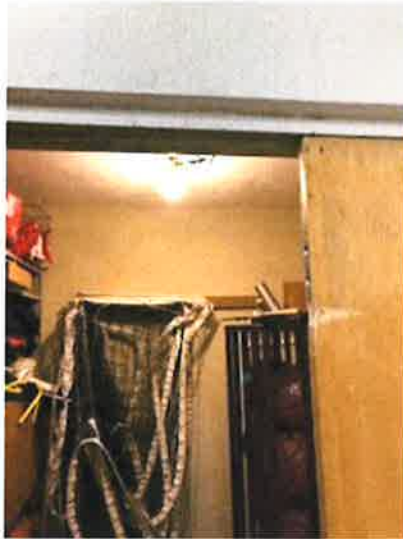
Photo 3 – Exposed Light Bulb

An exposed light bulb creates a shock hazard. The site should consider covering the exposed light bulb in the supply room to prevent accidental contact with the light fixture.

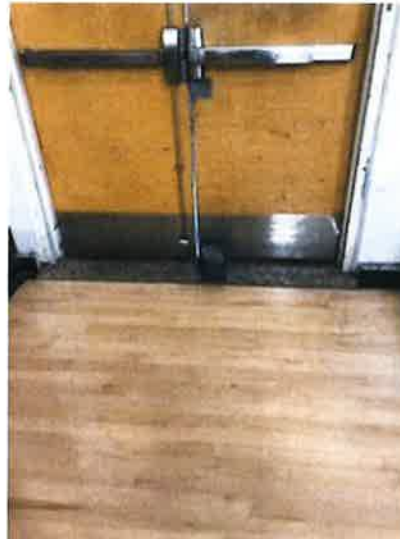
Photo 4 – Trip Fall Hazard

Using random items as a door stop creates a trip fall hazard. The exercise block used to prop the gym door open should be replaced with a device designed as a door stop.

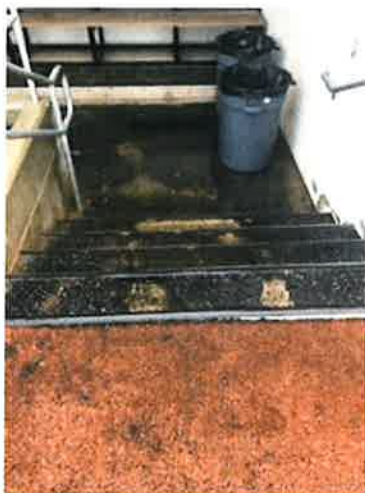
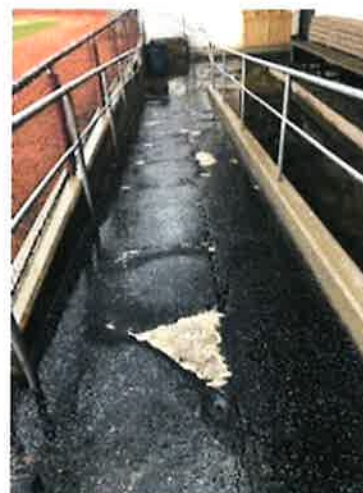
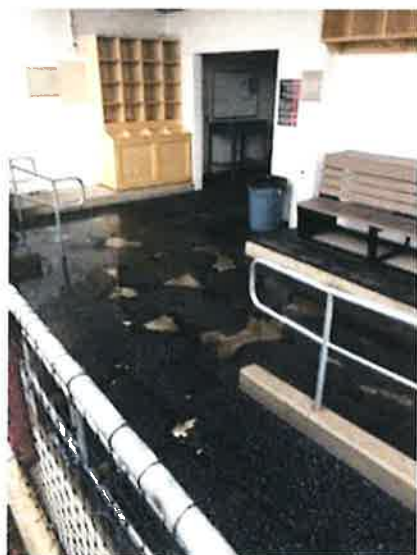
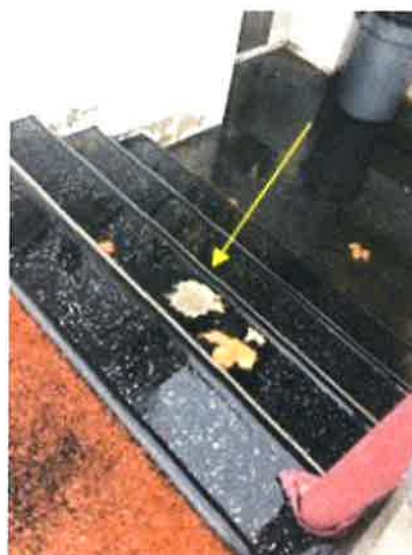
The dugout steps and walkway pose a trip fall hazard. The site should consider replacing the damaged surface material. The surface material is worn in several areas on the steps, ramp, and space in front of the bench. Most of the surface wear is on the home side due to regular use during practices. The AVC teams practice and use the space on a regular basis; however, the visitor's side has some damage near the top of stairs.

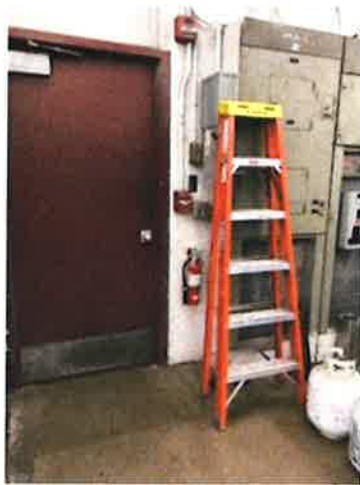
Photo 9 – Ladder Storage

The ladder stored near the door is obstructing access to the fire extinguisher and should be relocated and secured away from a door way. Access to the fire extinguisher must remain clear.

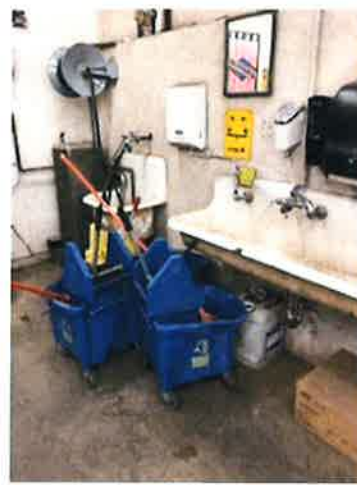
Photo 10 – Obstructed Eye Station

The area around the eyewash station is obstructed with cleaning equipment. The site should consider storing the cleaning equipment in an area away from the eyewash station. Access to the eyewash station must remain free of obstacles at all times.

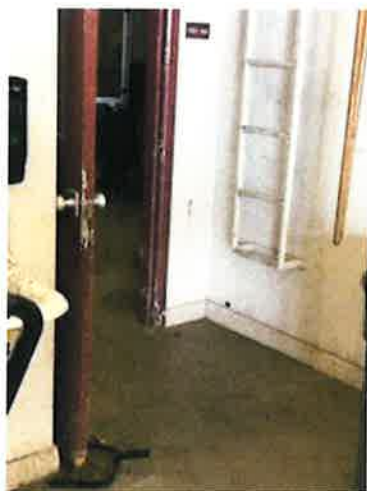
Photo 11 – Trip Fall Hazard

The practice of using miscellaneous items to hold doors open should be reconsidered. Using a dust pan to hold a door open creates a trip fall hazard. The site should consider replacing the dust pan with a customary door stop.

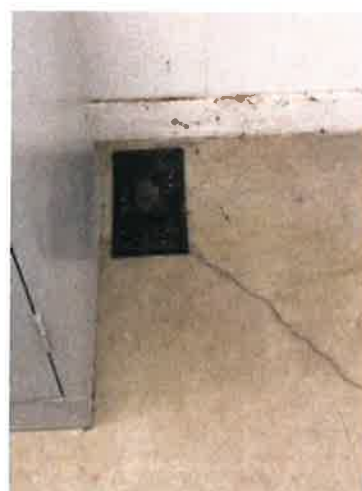
Photo 12 – Rodent Activity

TE2 Room 130 and surrounding rooms in the welding department have heavy rodent activity. Rodents are linked to several zoonotic diseases which pose serious health risk to humans. The entire area smelled of rodents and sounds of rodent movement can be heard above. The site should consider aggressive methods to remove the rodents.

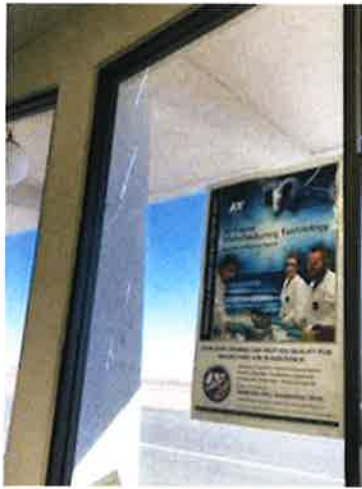
Photo 13 – Broken Window

The window located in the computer area is broken from the outside. The window is covered with window tint; however, birds continue to fly into the glass. It is unclear if the tint is reflective due to the security restrictions around the building. Outside access is restricted to authorized military personnel.

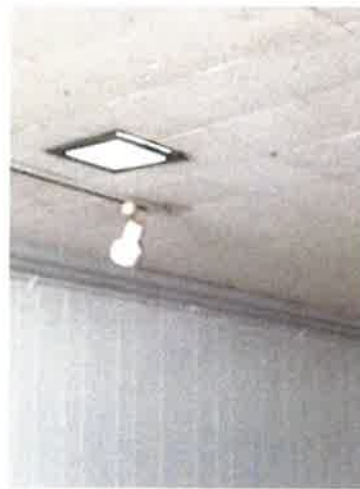
Photo 14 – Loose Ceiling Tiles and Fixture

The ceiling in the computer room has loose light fixtures and ceiling tiles. The ceiling fixtures and tiles should be secured.

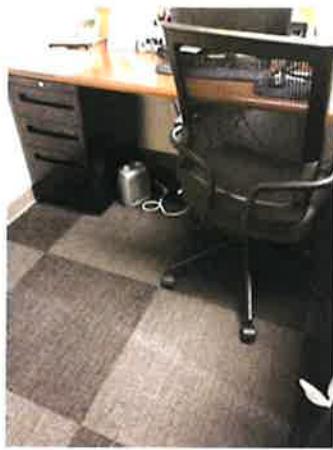
Photo 15 – Office 129

Space heaters create a fire hazard. Space heaters create fire hazards as there is a risk for the employee to leave the device unattended. The device may overheat or damage cords located under the employee's desk. The site had several offices with space heaters. The site should review the policy for bringing personal home appliances into the workspace.

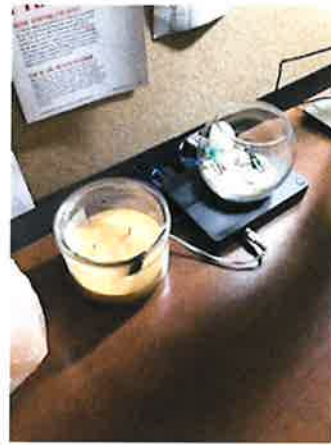
Photo 16 – Candles in the Workplace

Candles and other open flames should not be allowed in the workplace.

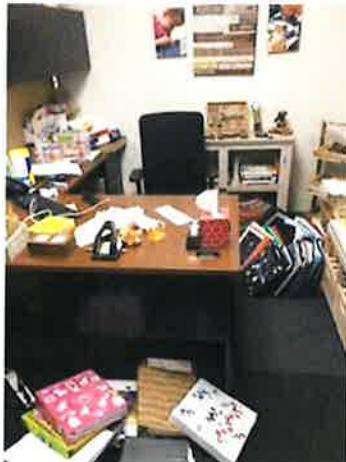
Photo 17 – Trip Fall Hazard Housekeeping

Poor housekeeping standards is a common cause for trip and fall. Office occupants should be encouraged to maintain clear access to the exit.

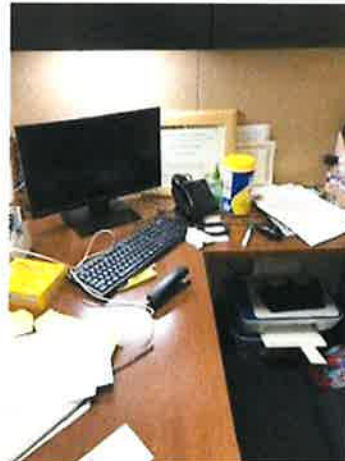
Photo 18 – Ergonomic Recommendations

Employees should be encouraged to use ergonomic guidelines when establishing office space. Desks with sharp 90° connection points create an awkward position for prolonged typing.

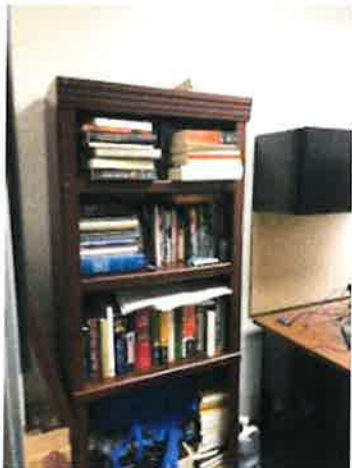
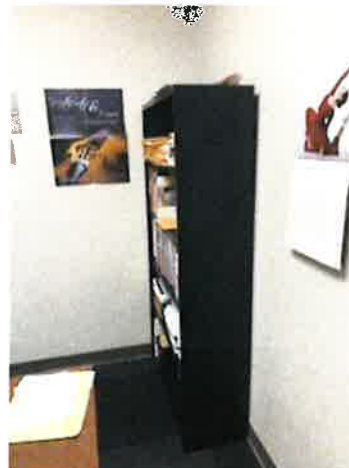
In Rooms 105 and 109, the bookcases should be secured to the wall. Tall items such as bookcases are known to tip over during seismic activity.

Photo 19 – Office 109: Secure Bookcase.

Photo 20 – Office 105: Secure Bookcase.

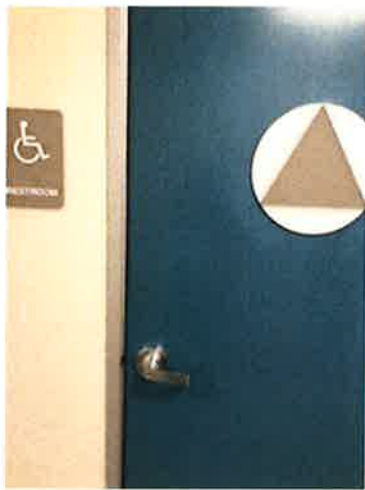
The unisex restroom should have an occupied indicator latch. Currently, occupants must call out when the door handle is rattled.

Photo 21 – Unisex Restroom: Consider Using an Occupied Sign.

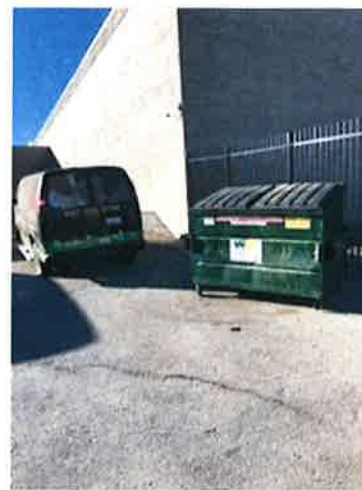
Photo 22 – Obstructed Emergency Exit

The emergency exit is obstructed by a dumpster and a disabled van. The items belong to tenants in a neighboring business. Although the obstructions do not fully block emergency egress, it narrows the exit route. The site should contact property management and have the obstructions moved.
